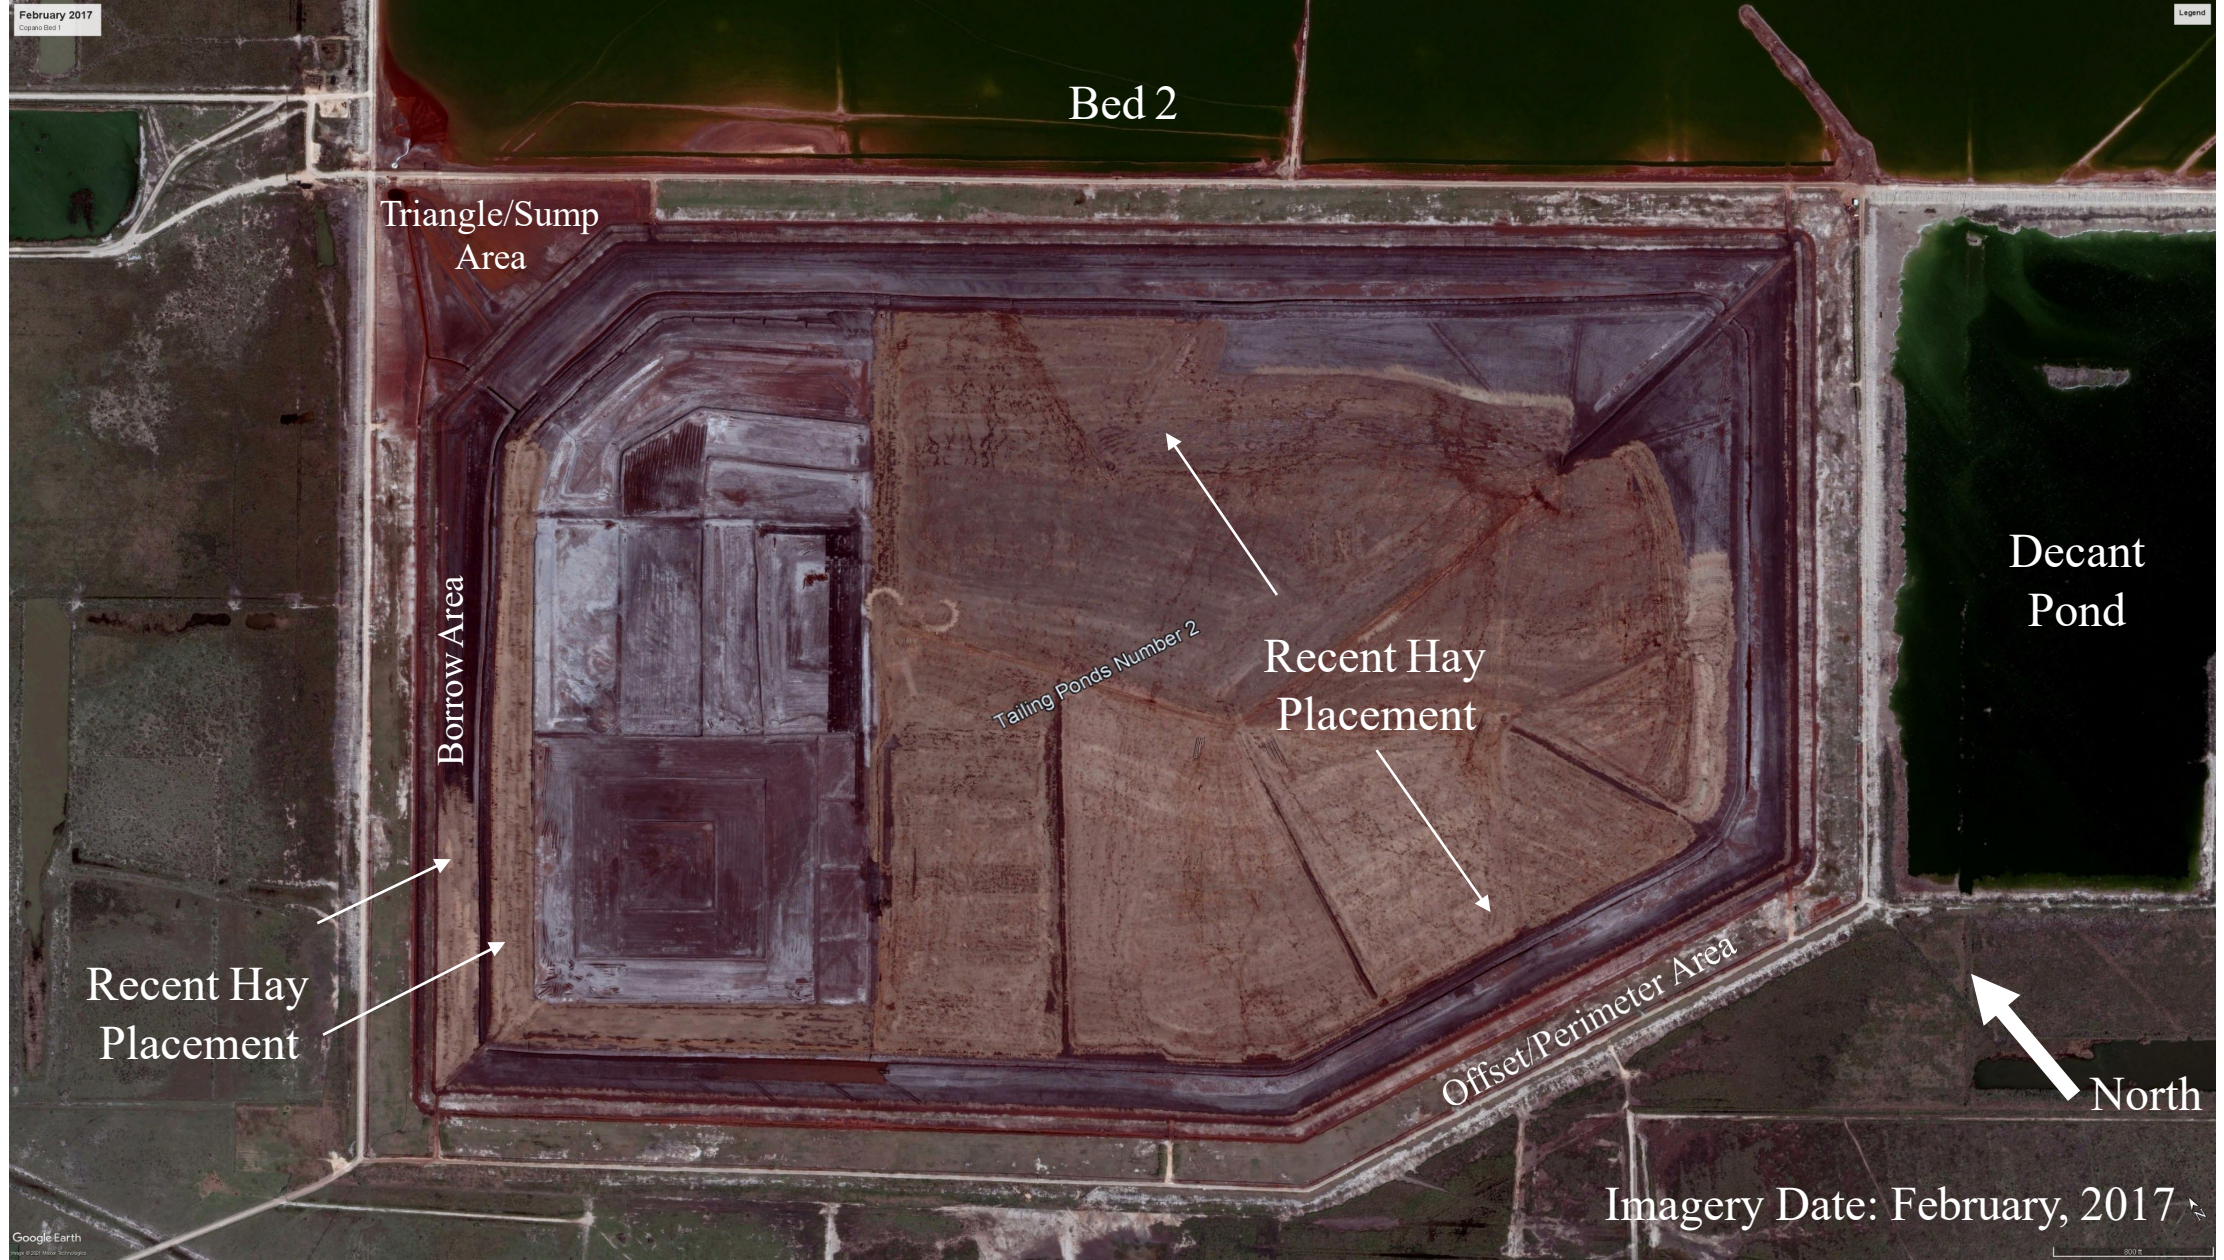
Google Earth imagery shows hay placement and disking activities during Sherwin Alumina ownership.

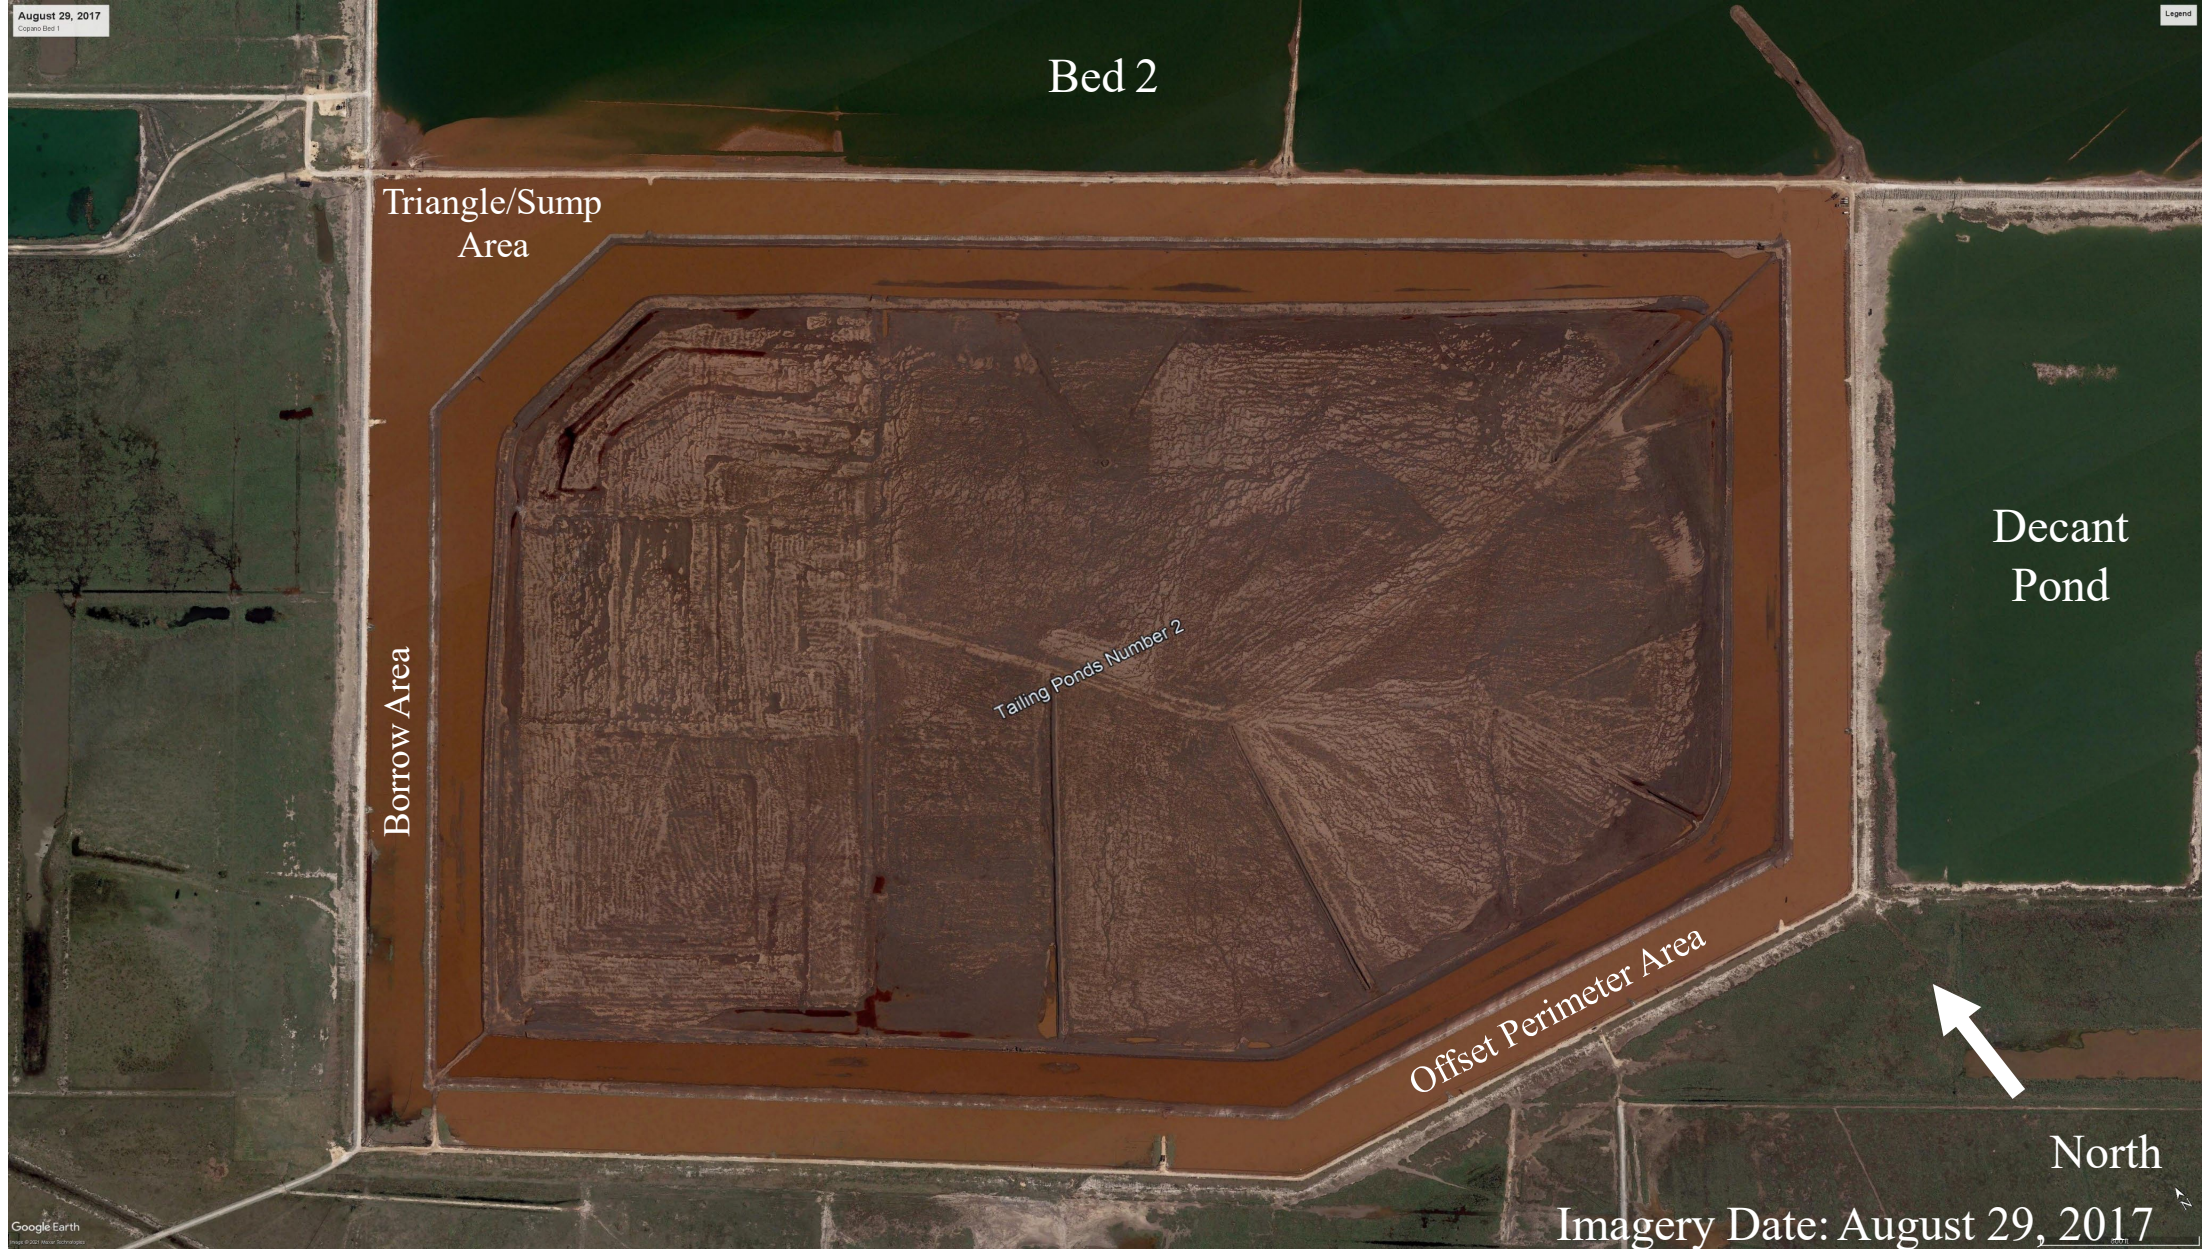
Google Earth imagery (Post-Hurricane Harvey) shows Offset/Perimeter and Borrow Areas retaining stormwater runoff from the Inner Area, also during Sherwin Alumina ownership.

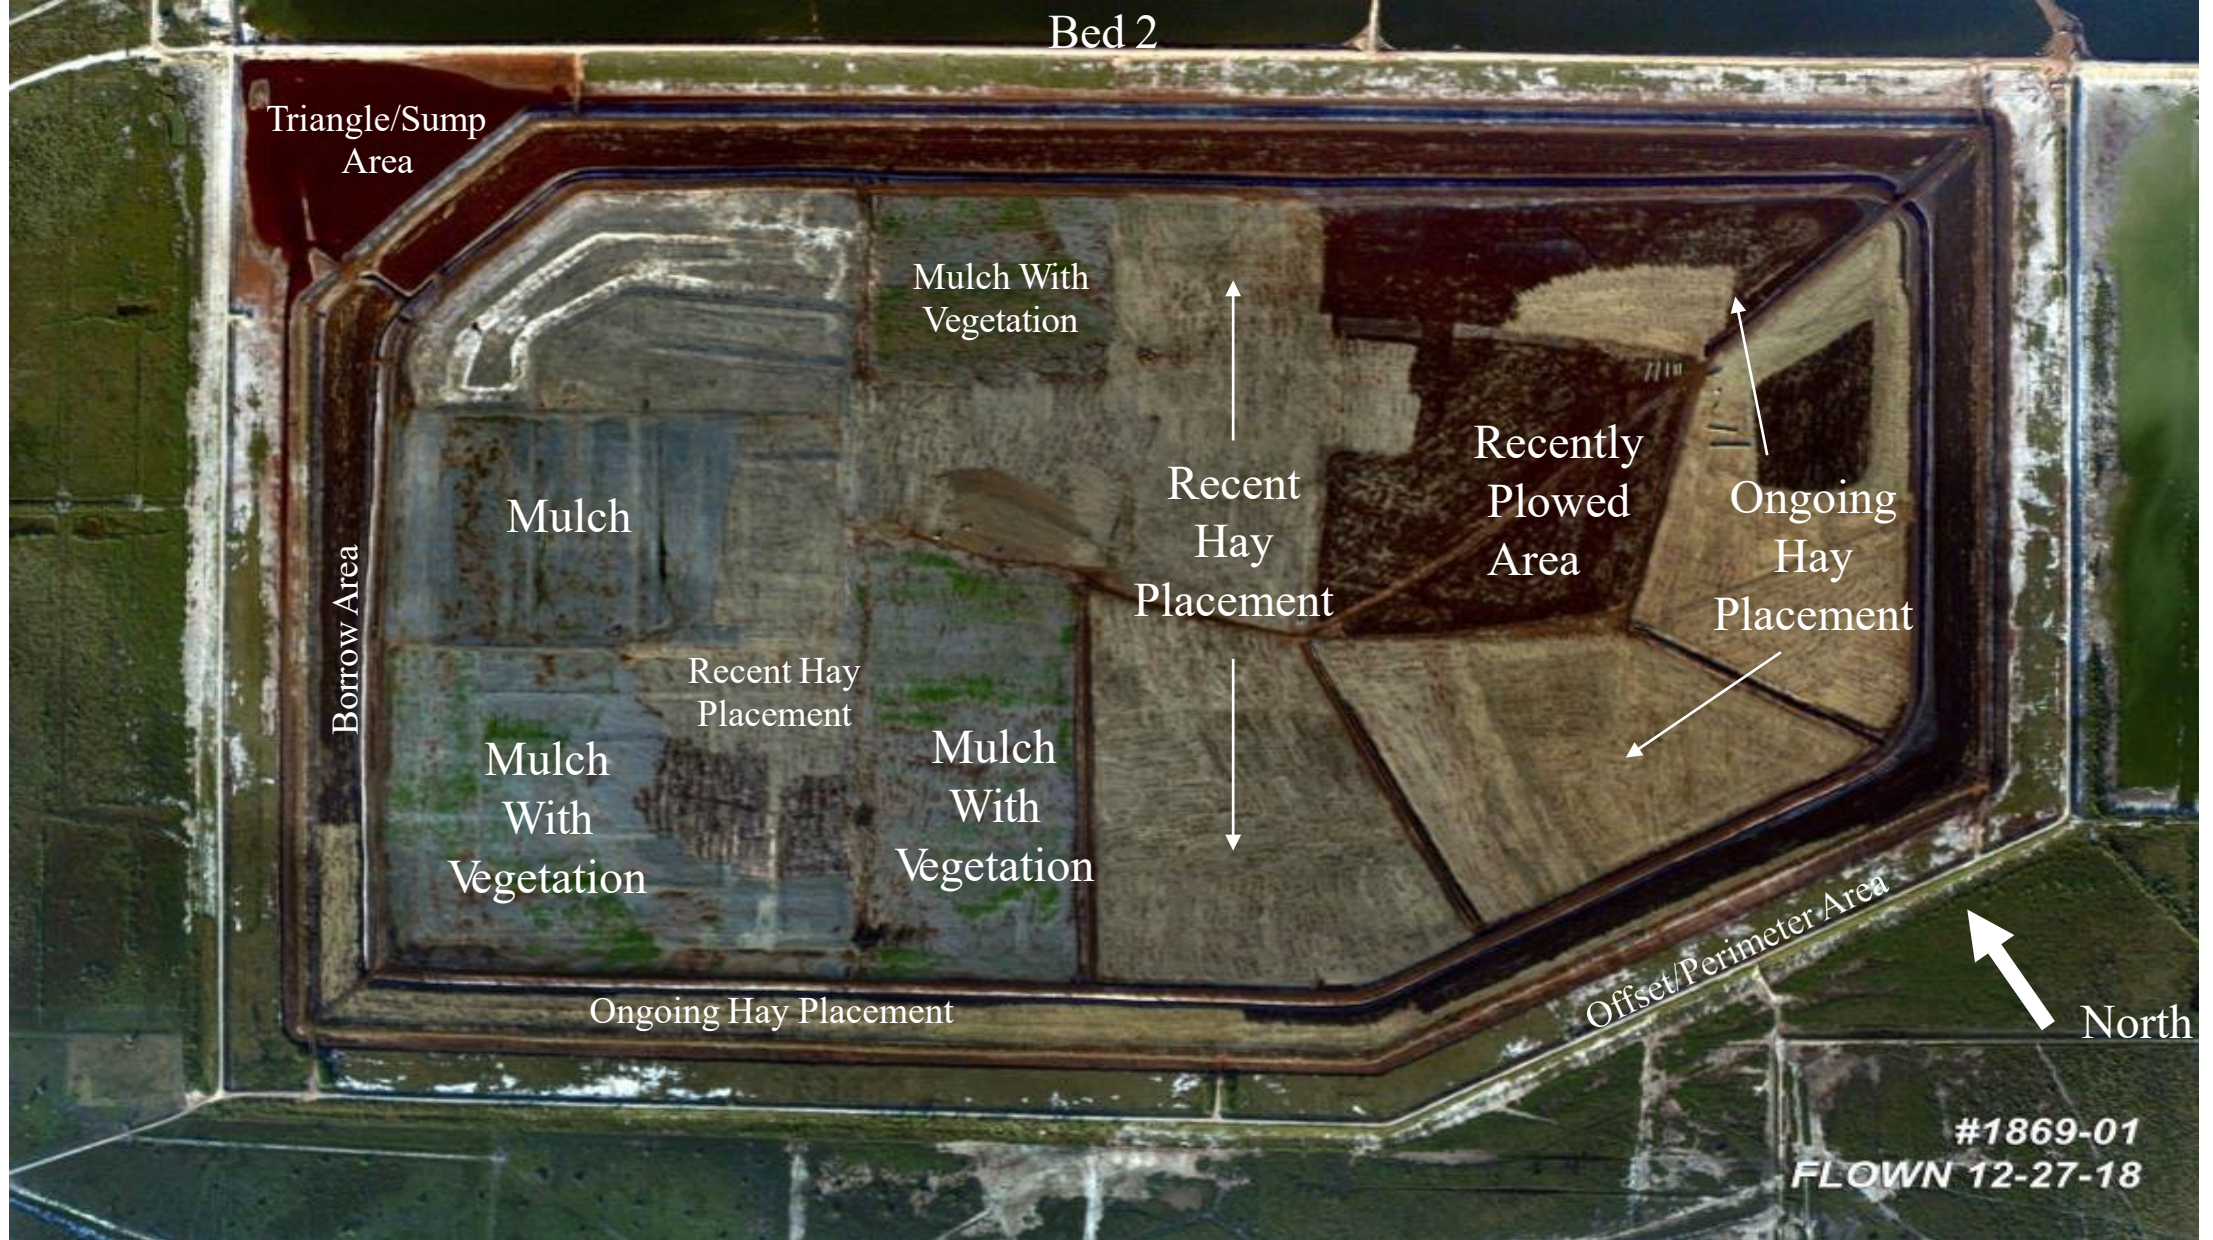
Aerial photograph shows mulch coverage across a majority of the western half of the Inner Area and ongoing hay placement activities and tillage across the eastern area. Triangle/sump area continues to be used for stormwater and leachate collection for subsequent pumping to Bed 2.

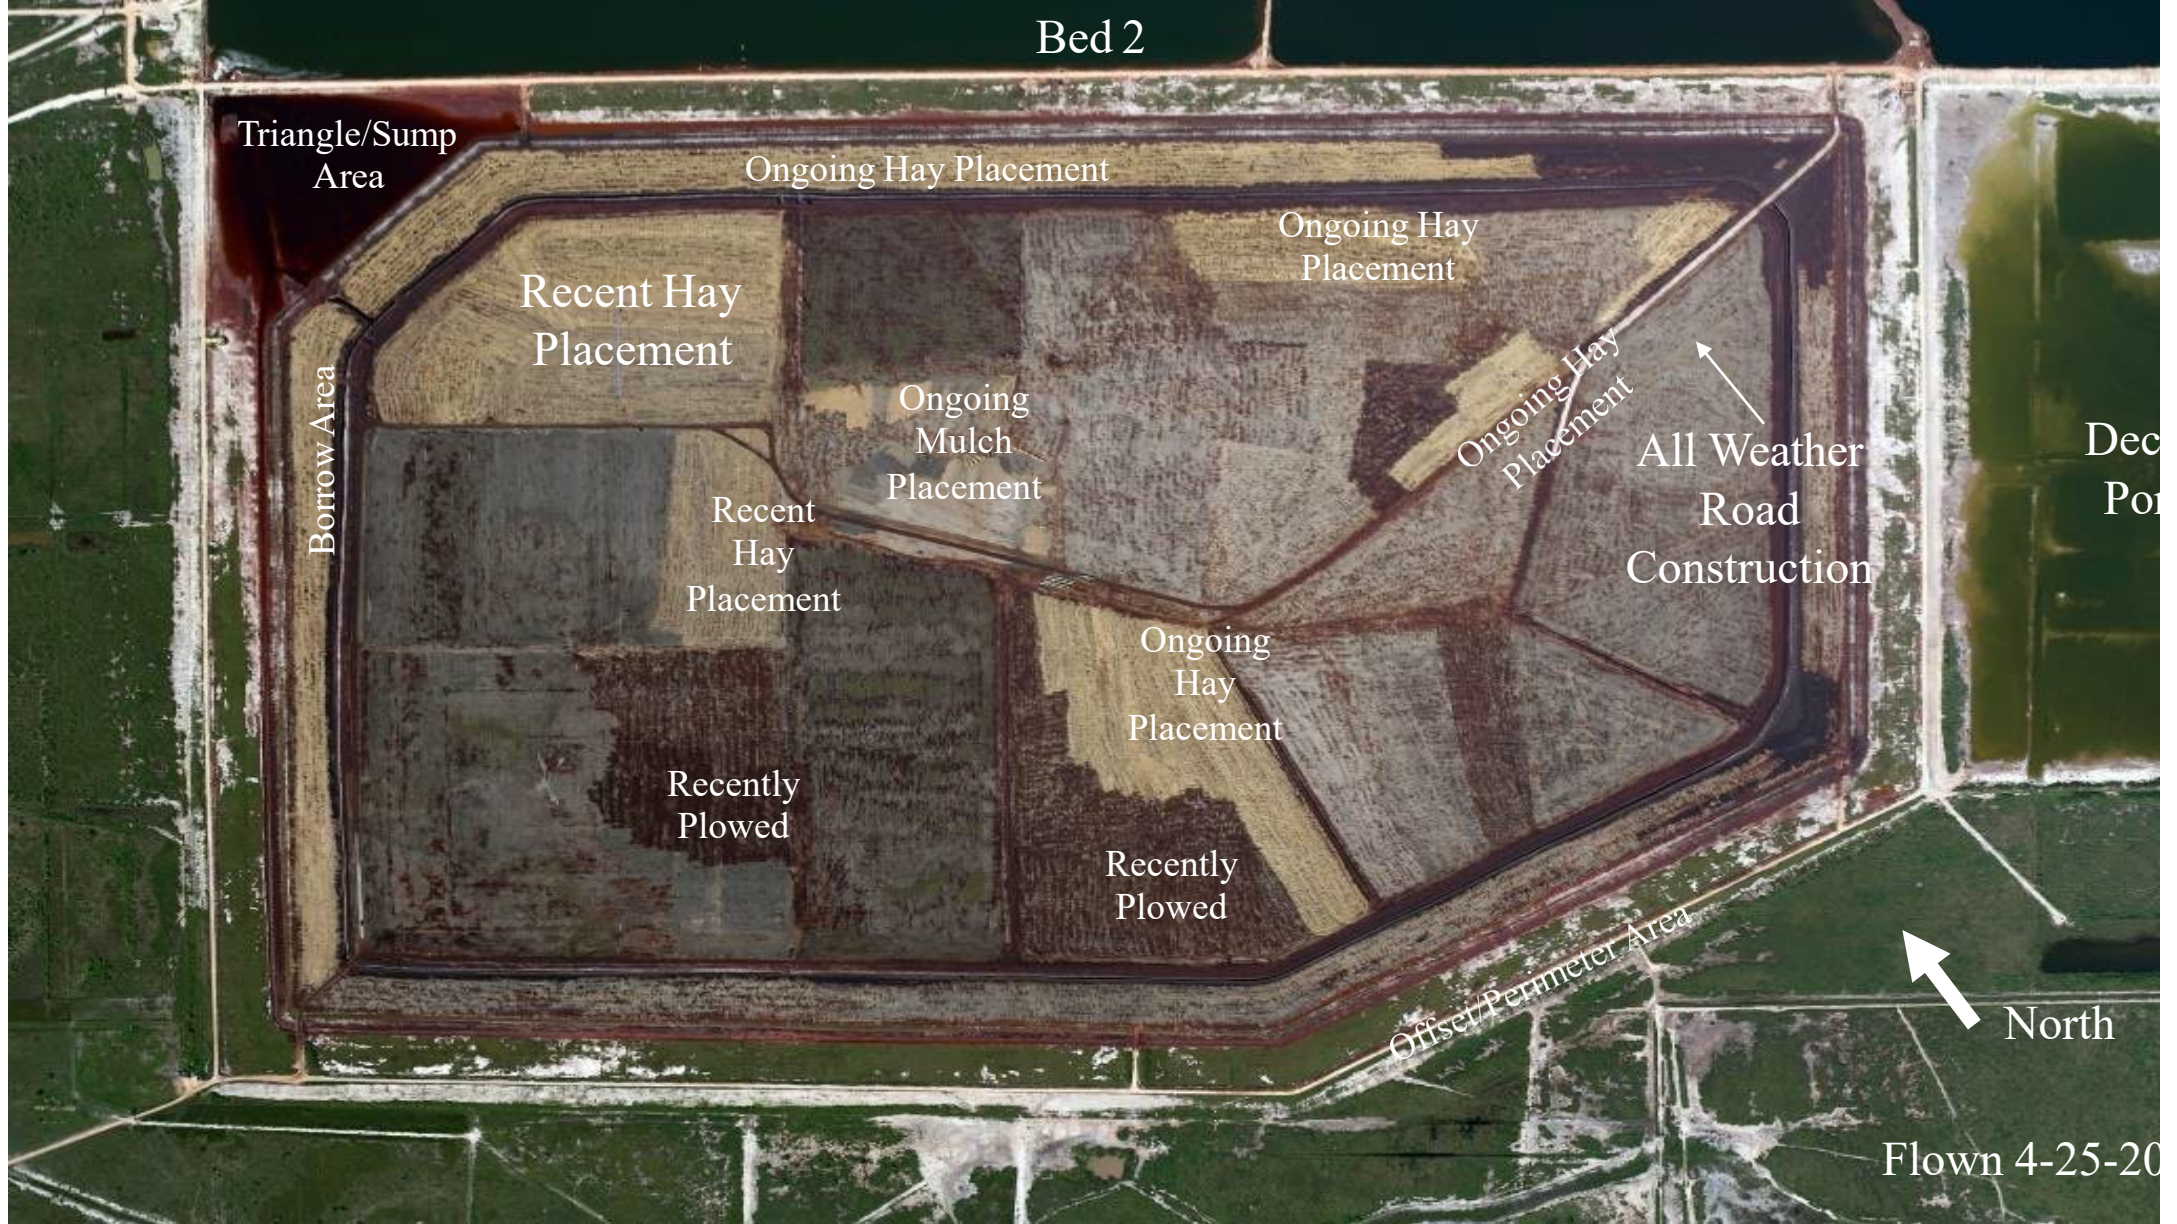
Aerial photograph shows hay and mulch placement areas along with the recently plowed areas. The construction of an all-weather road is ongoing to aide in material delivery.

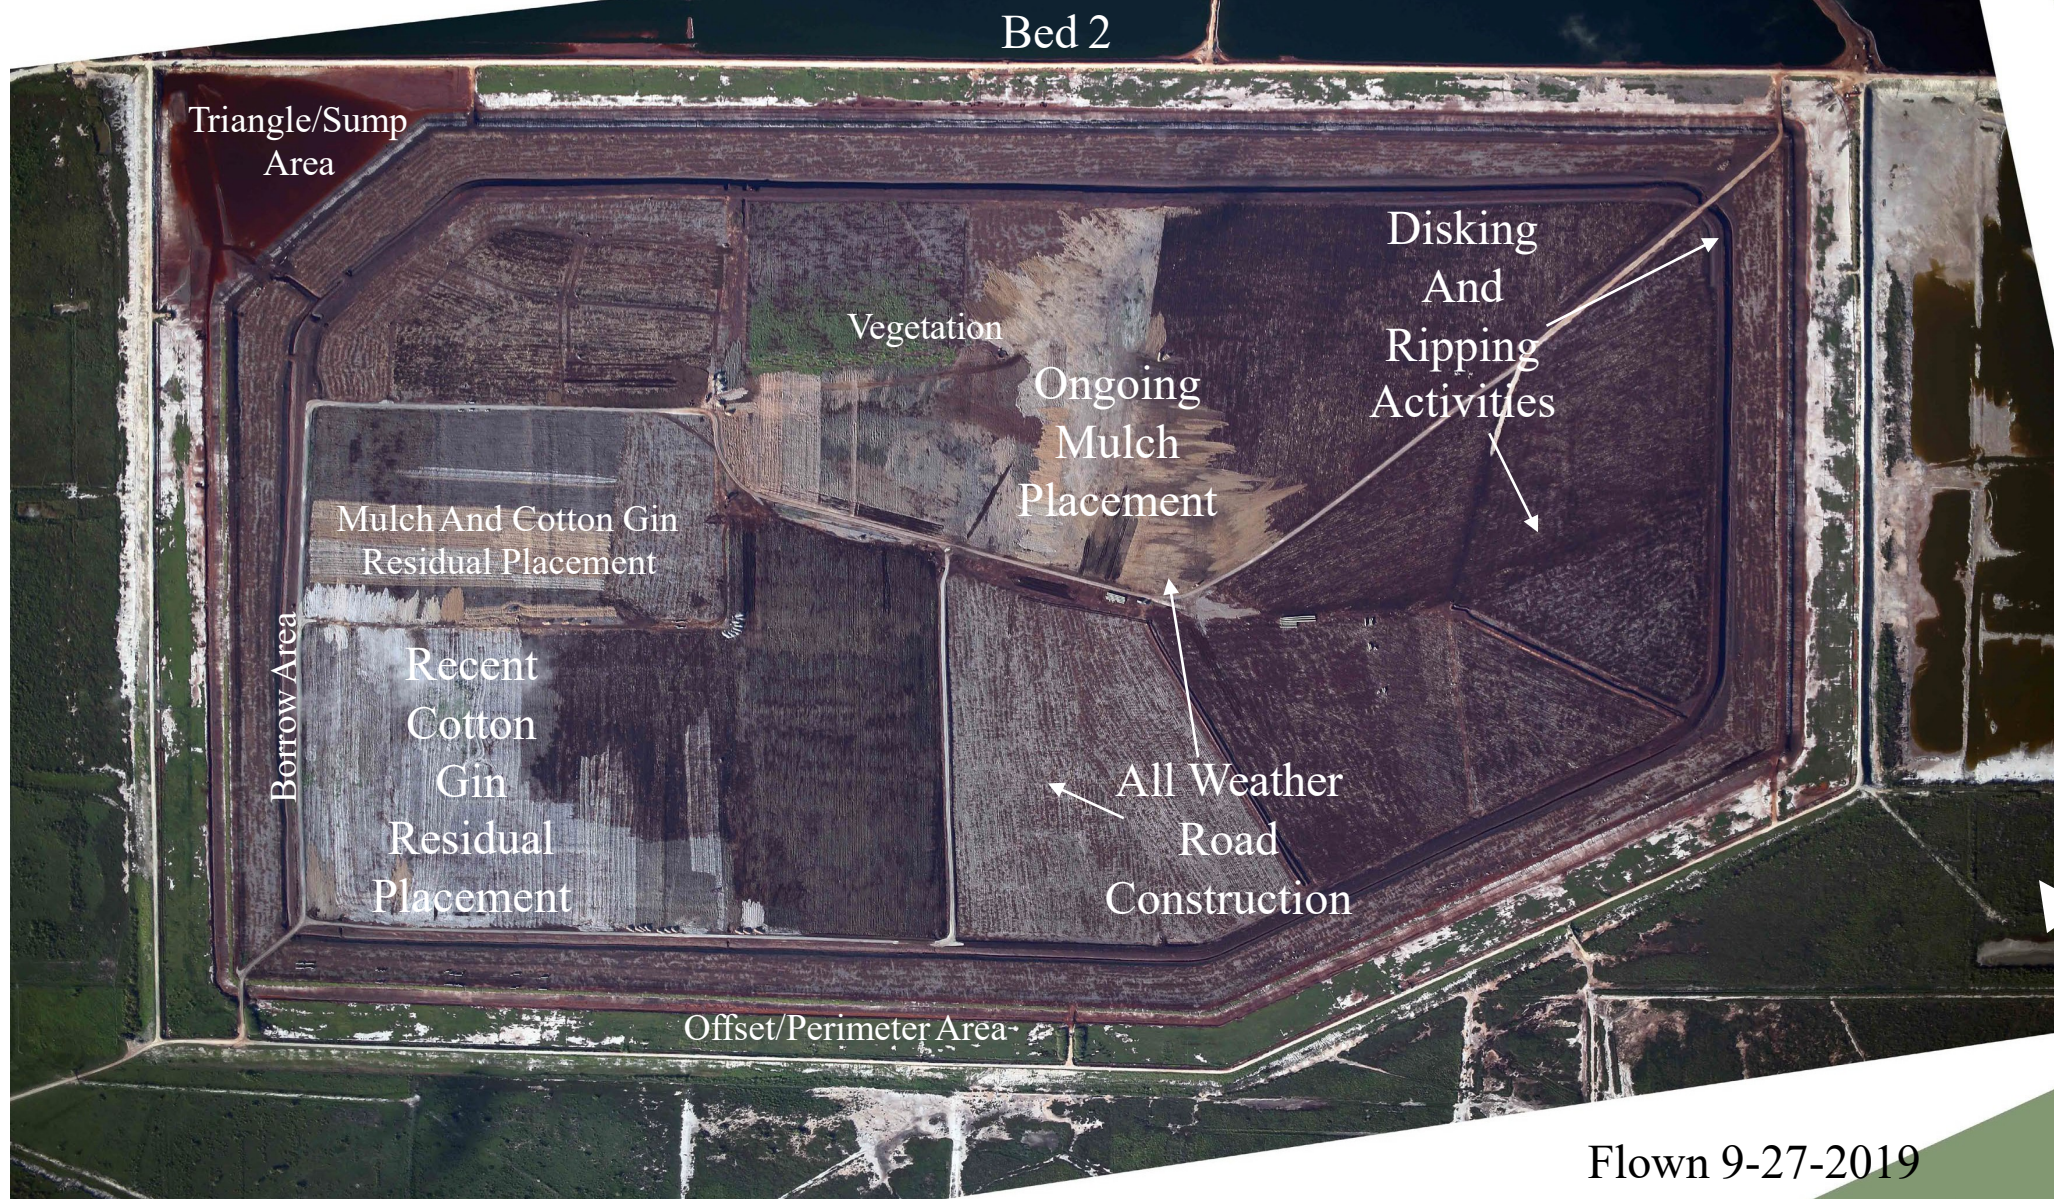
Aerial photograph shows continued all-weather road construction and placement areas for cotton gin residuals and mulch. Tillage activities (i.e., disking, plowing, ripping, etc.) also continue within the eastern area.

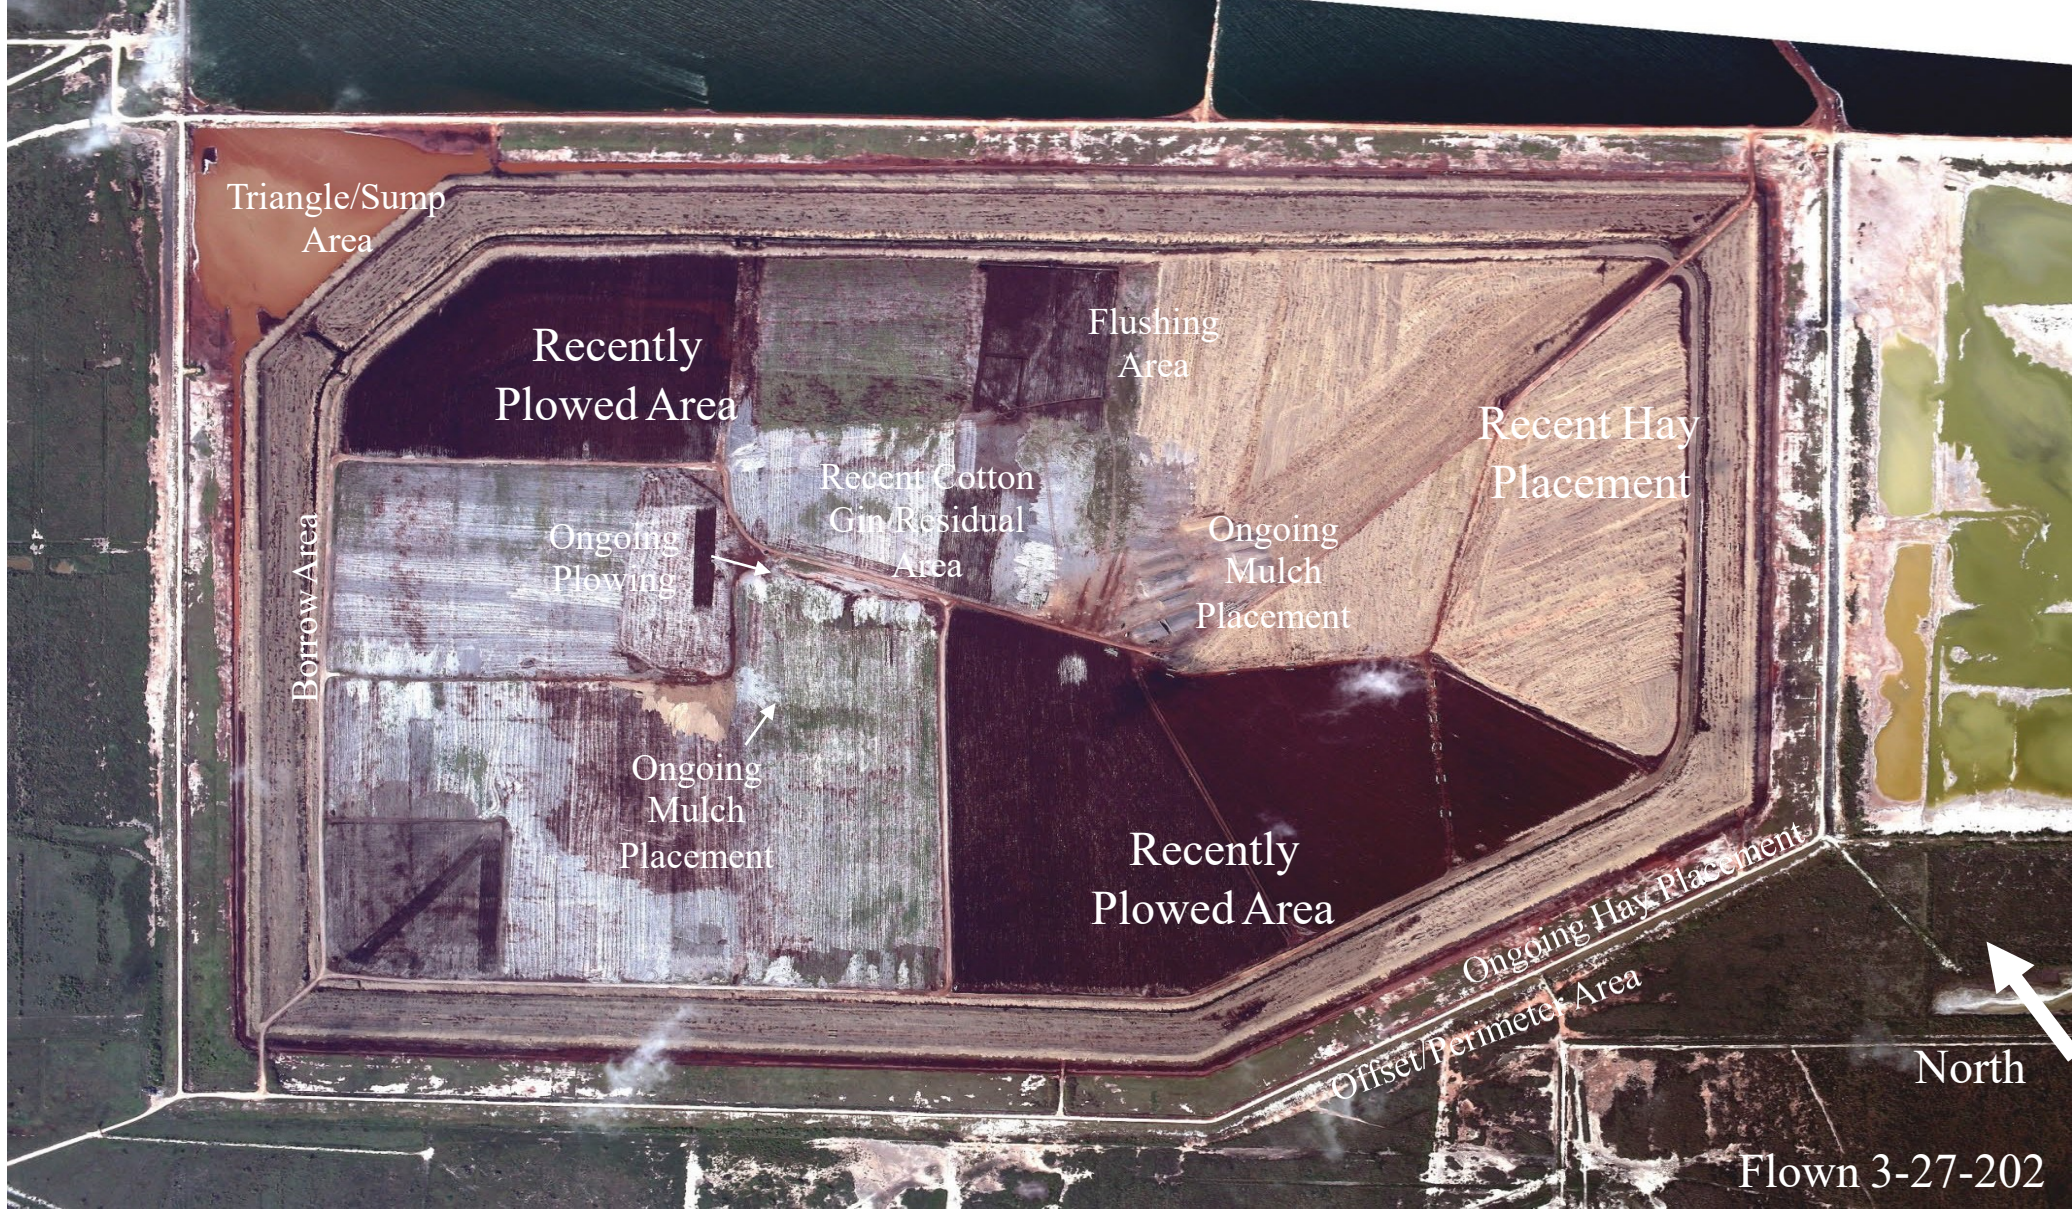
Aerial photograph shows hay, mulch, and cotton gin residual placement along with plowing and initiation of flushing.

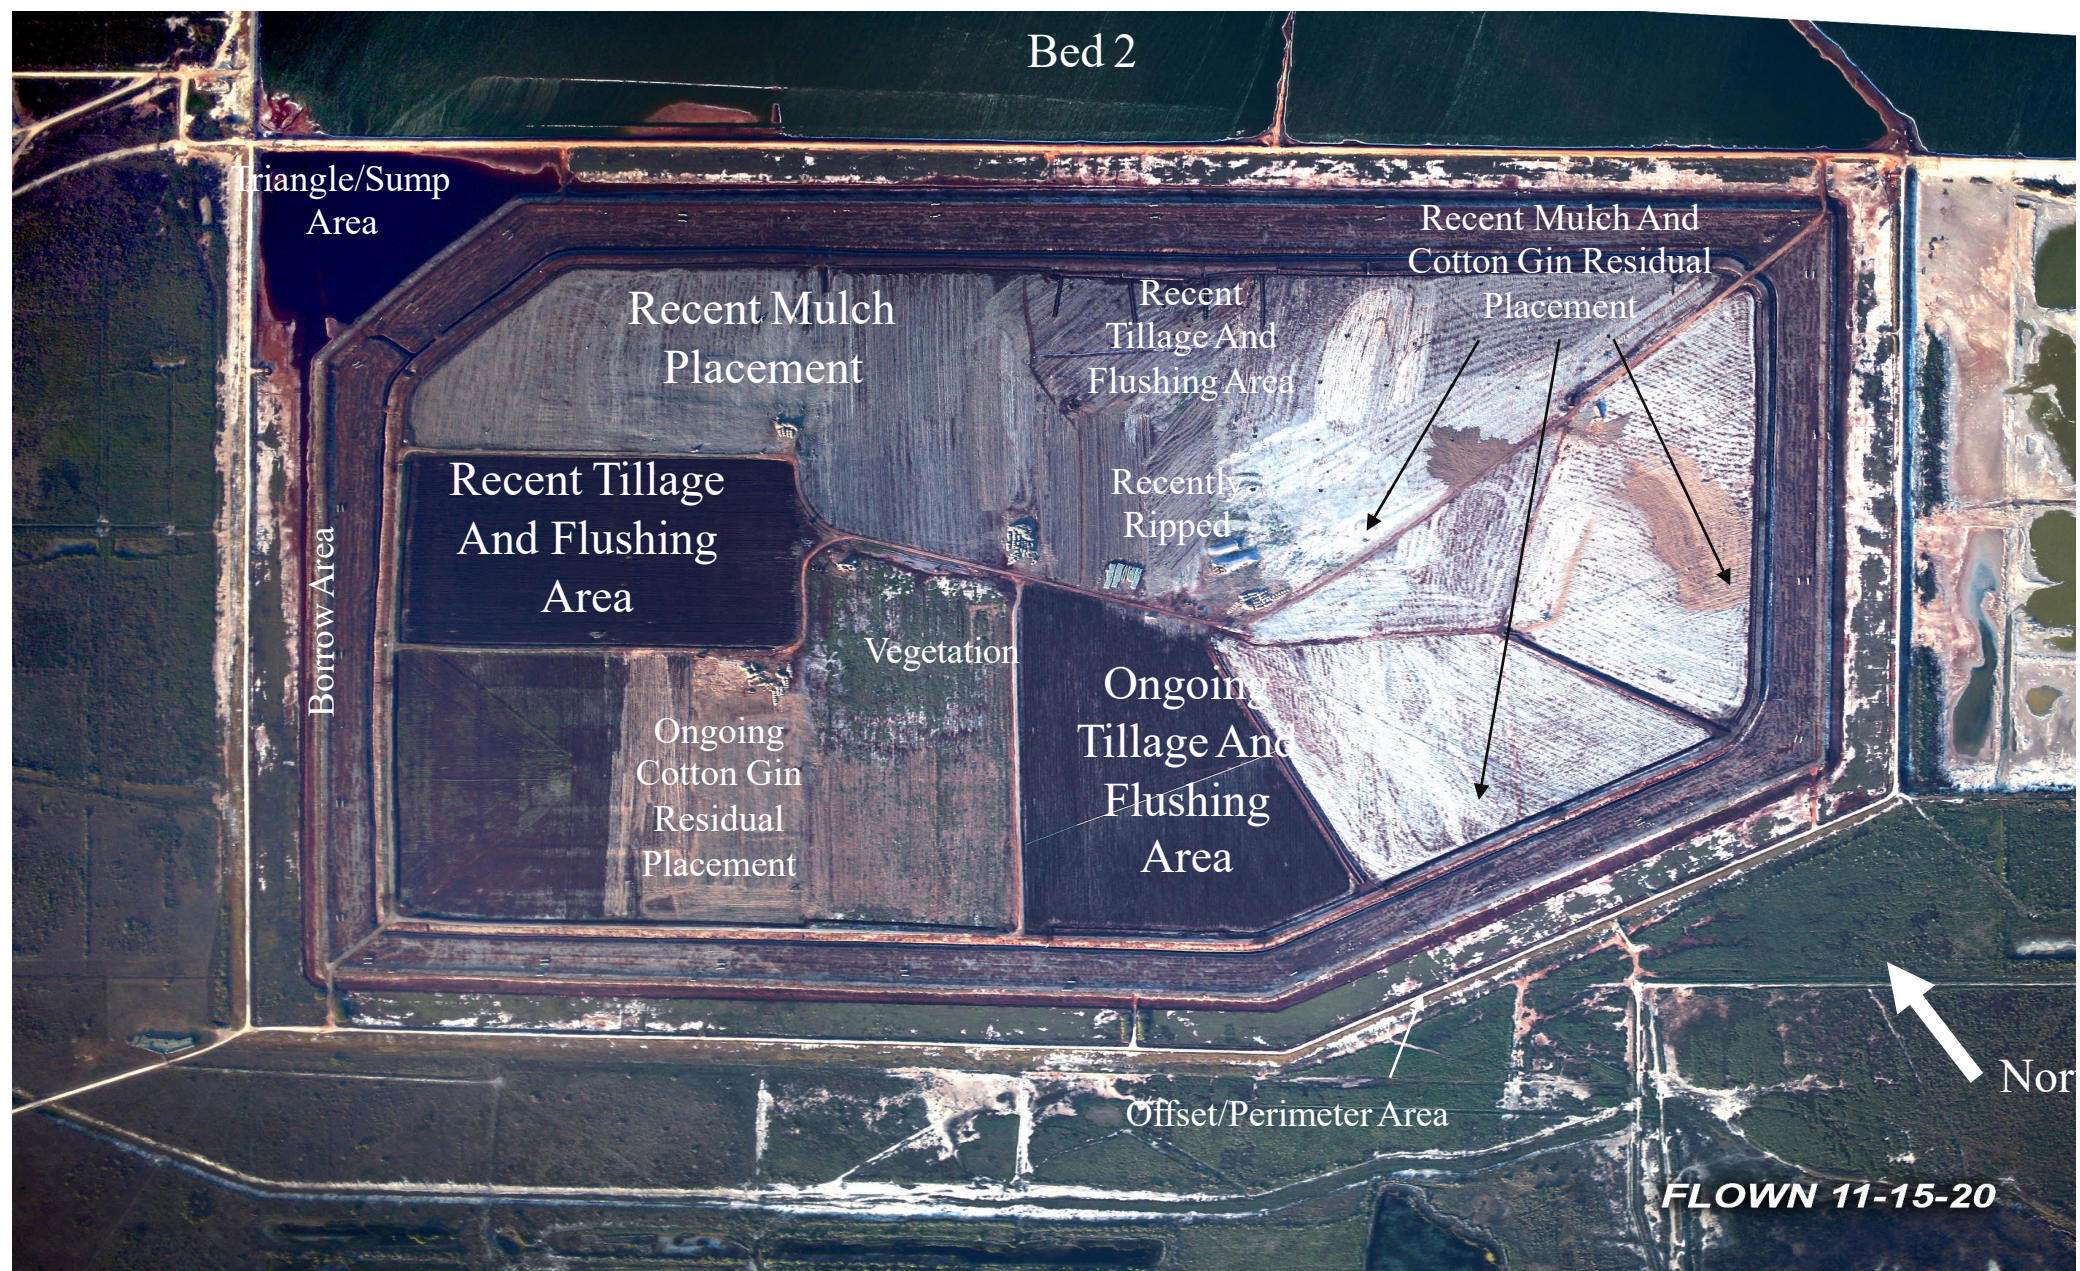
Aerial photograph shows continued tillage, flushing and mulch and cotton gin residual placement. Volunteer native vegetation begins to appear in mulched areas.

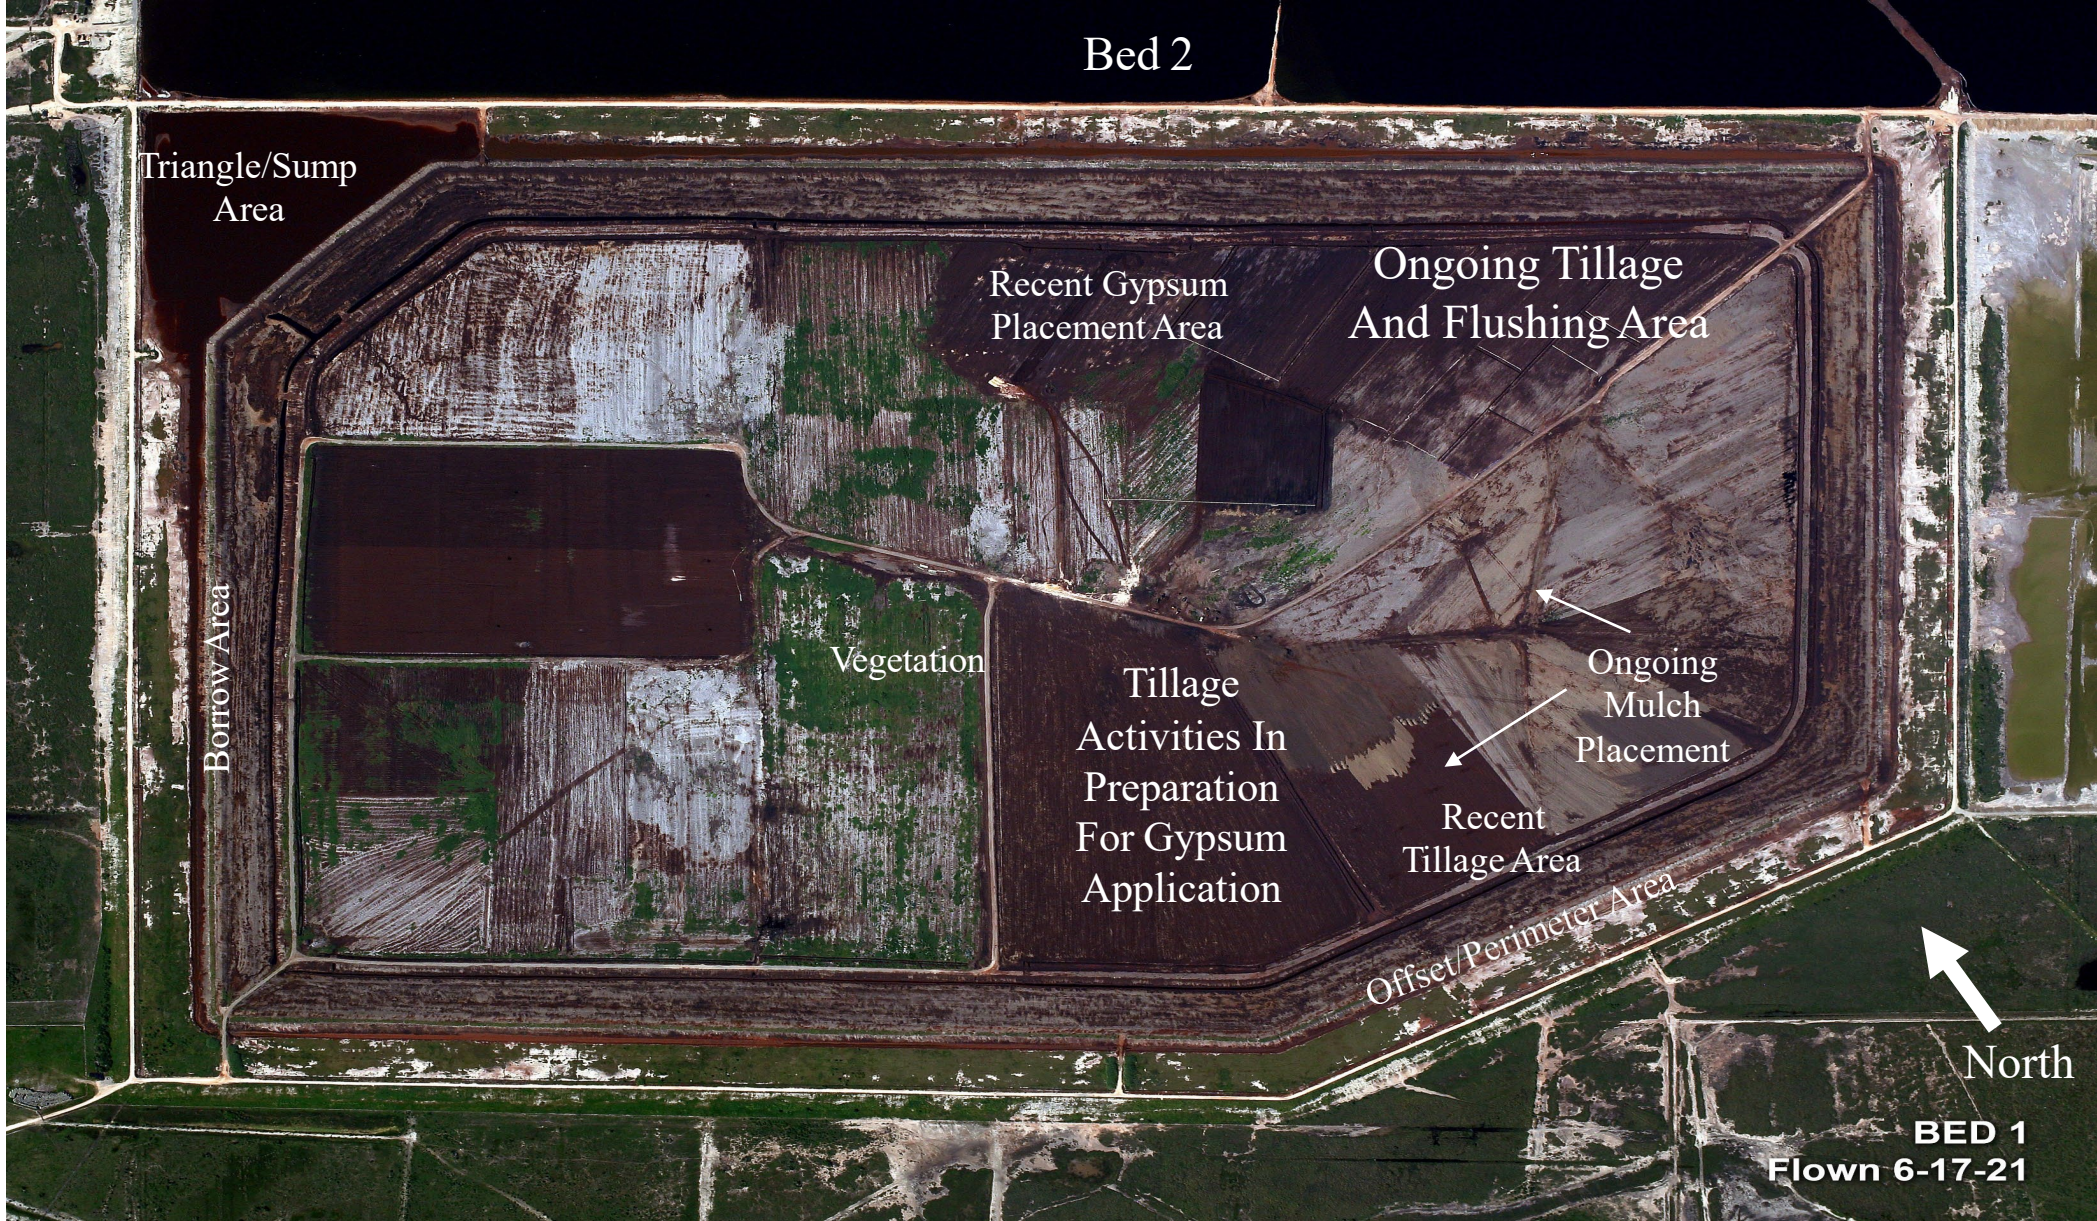
Aerial photograph shows ongoing mulch placement, tillage and flushing. Gypsum placement has begun; grass and other vegetation is becoming very abundant within areas across the bed.
