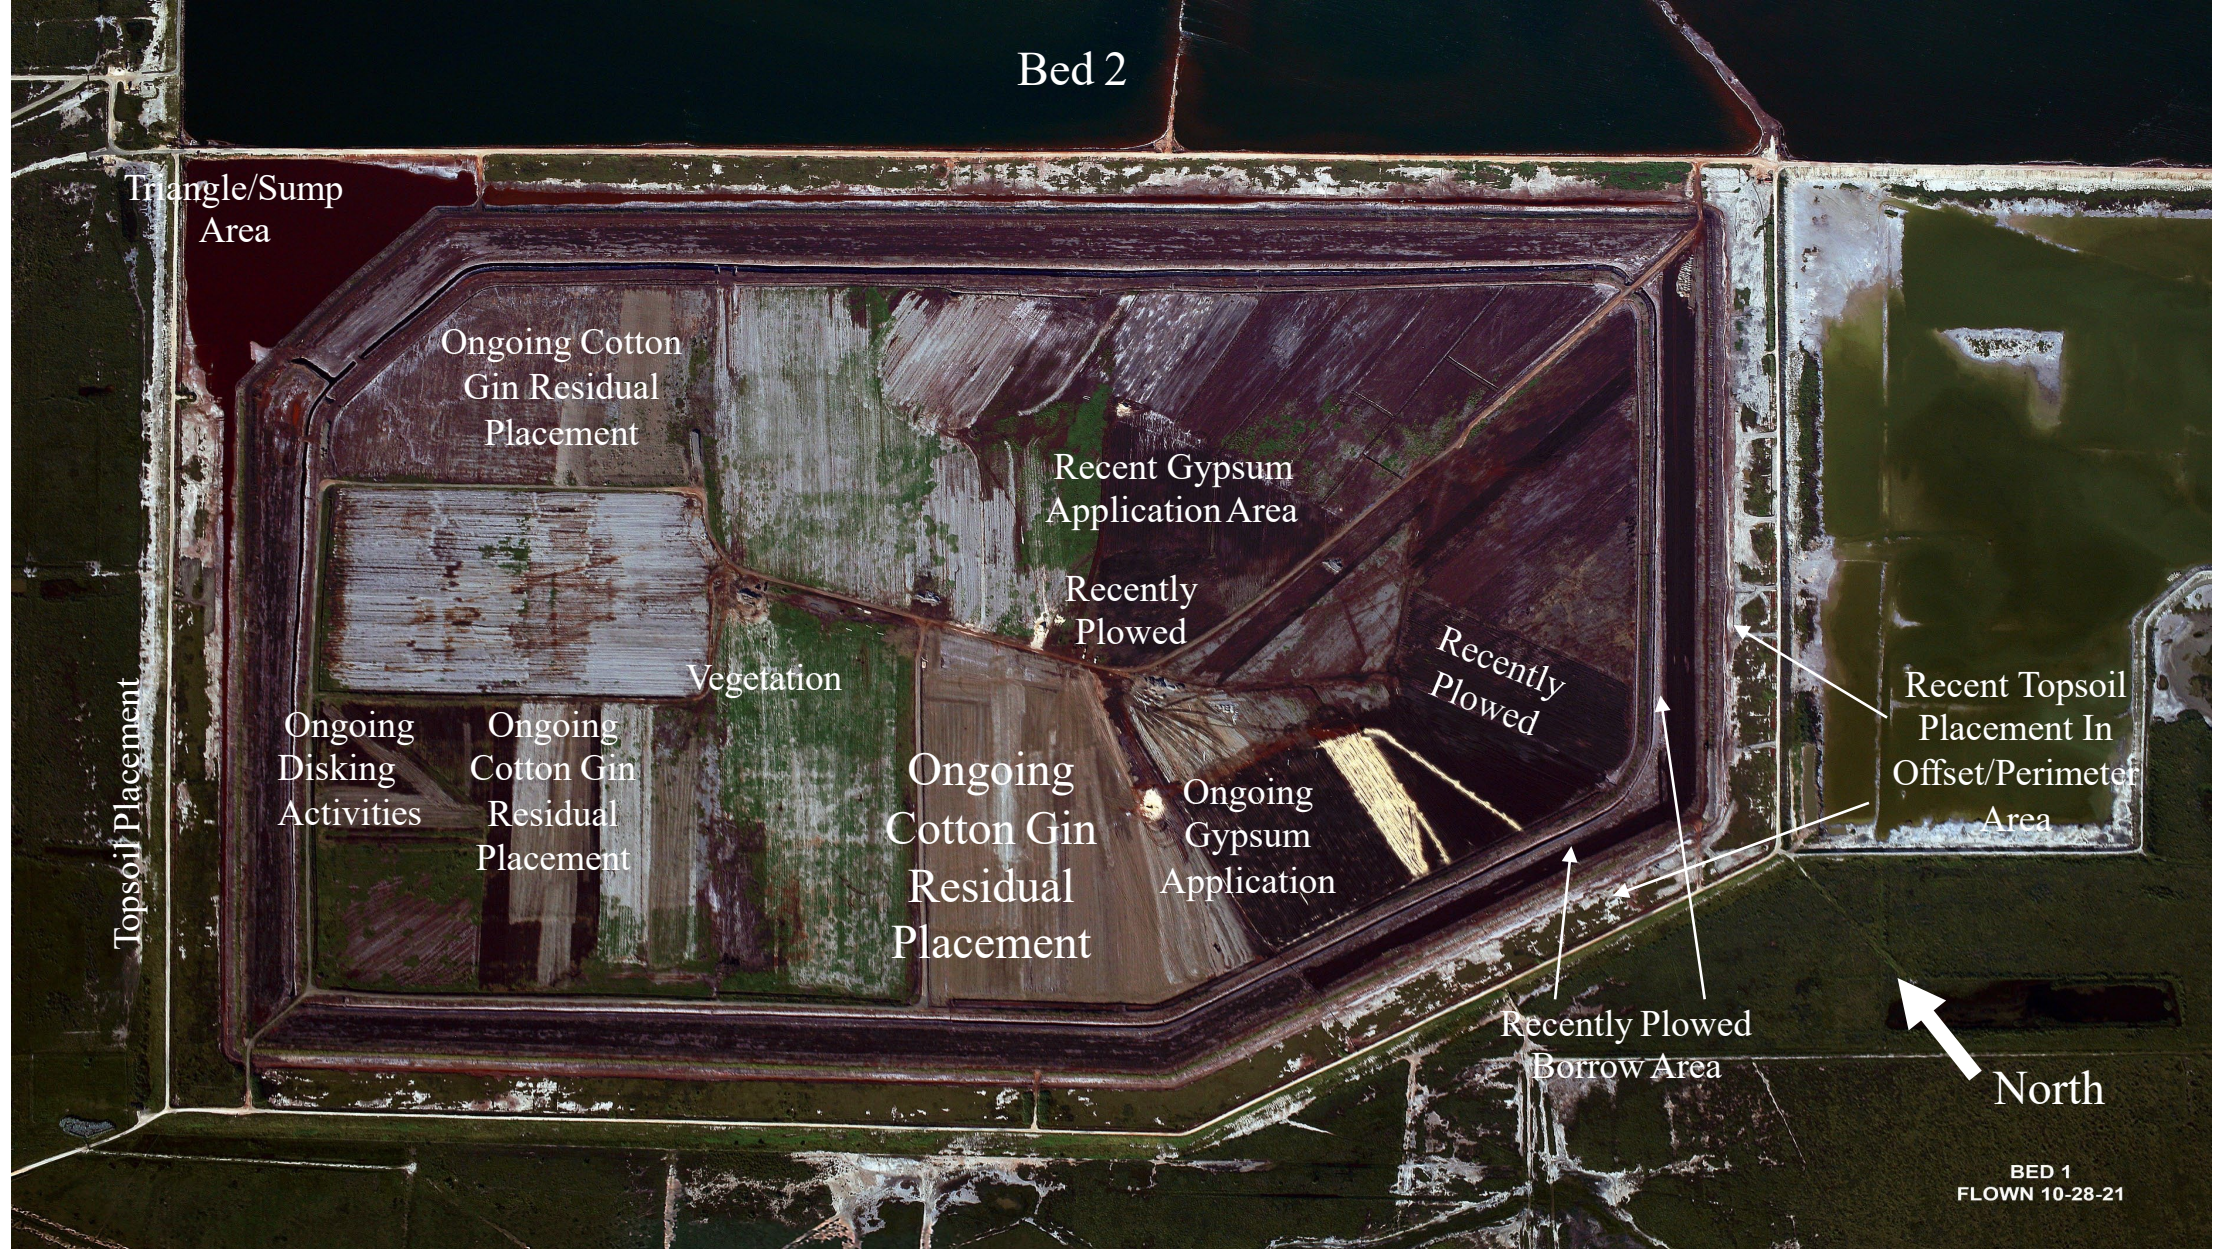
Aerial photograph show tillage (disking, ripping and plowing) activities along with gypsum and cotton gin residual placement. Topsoil continues to be placed within the Offset/Perimeter Area in preparation for reseeding.

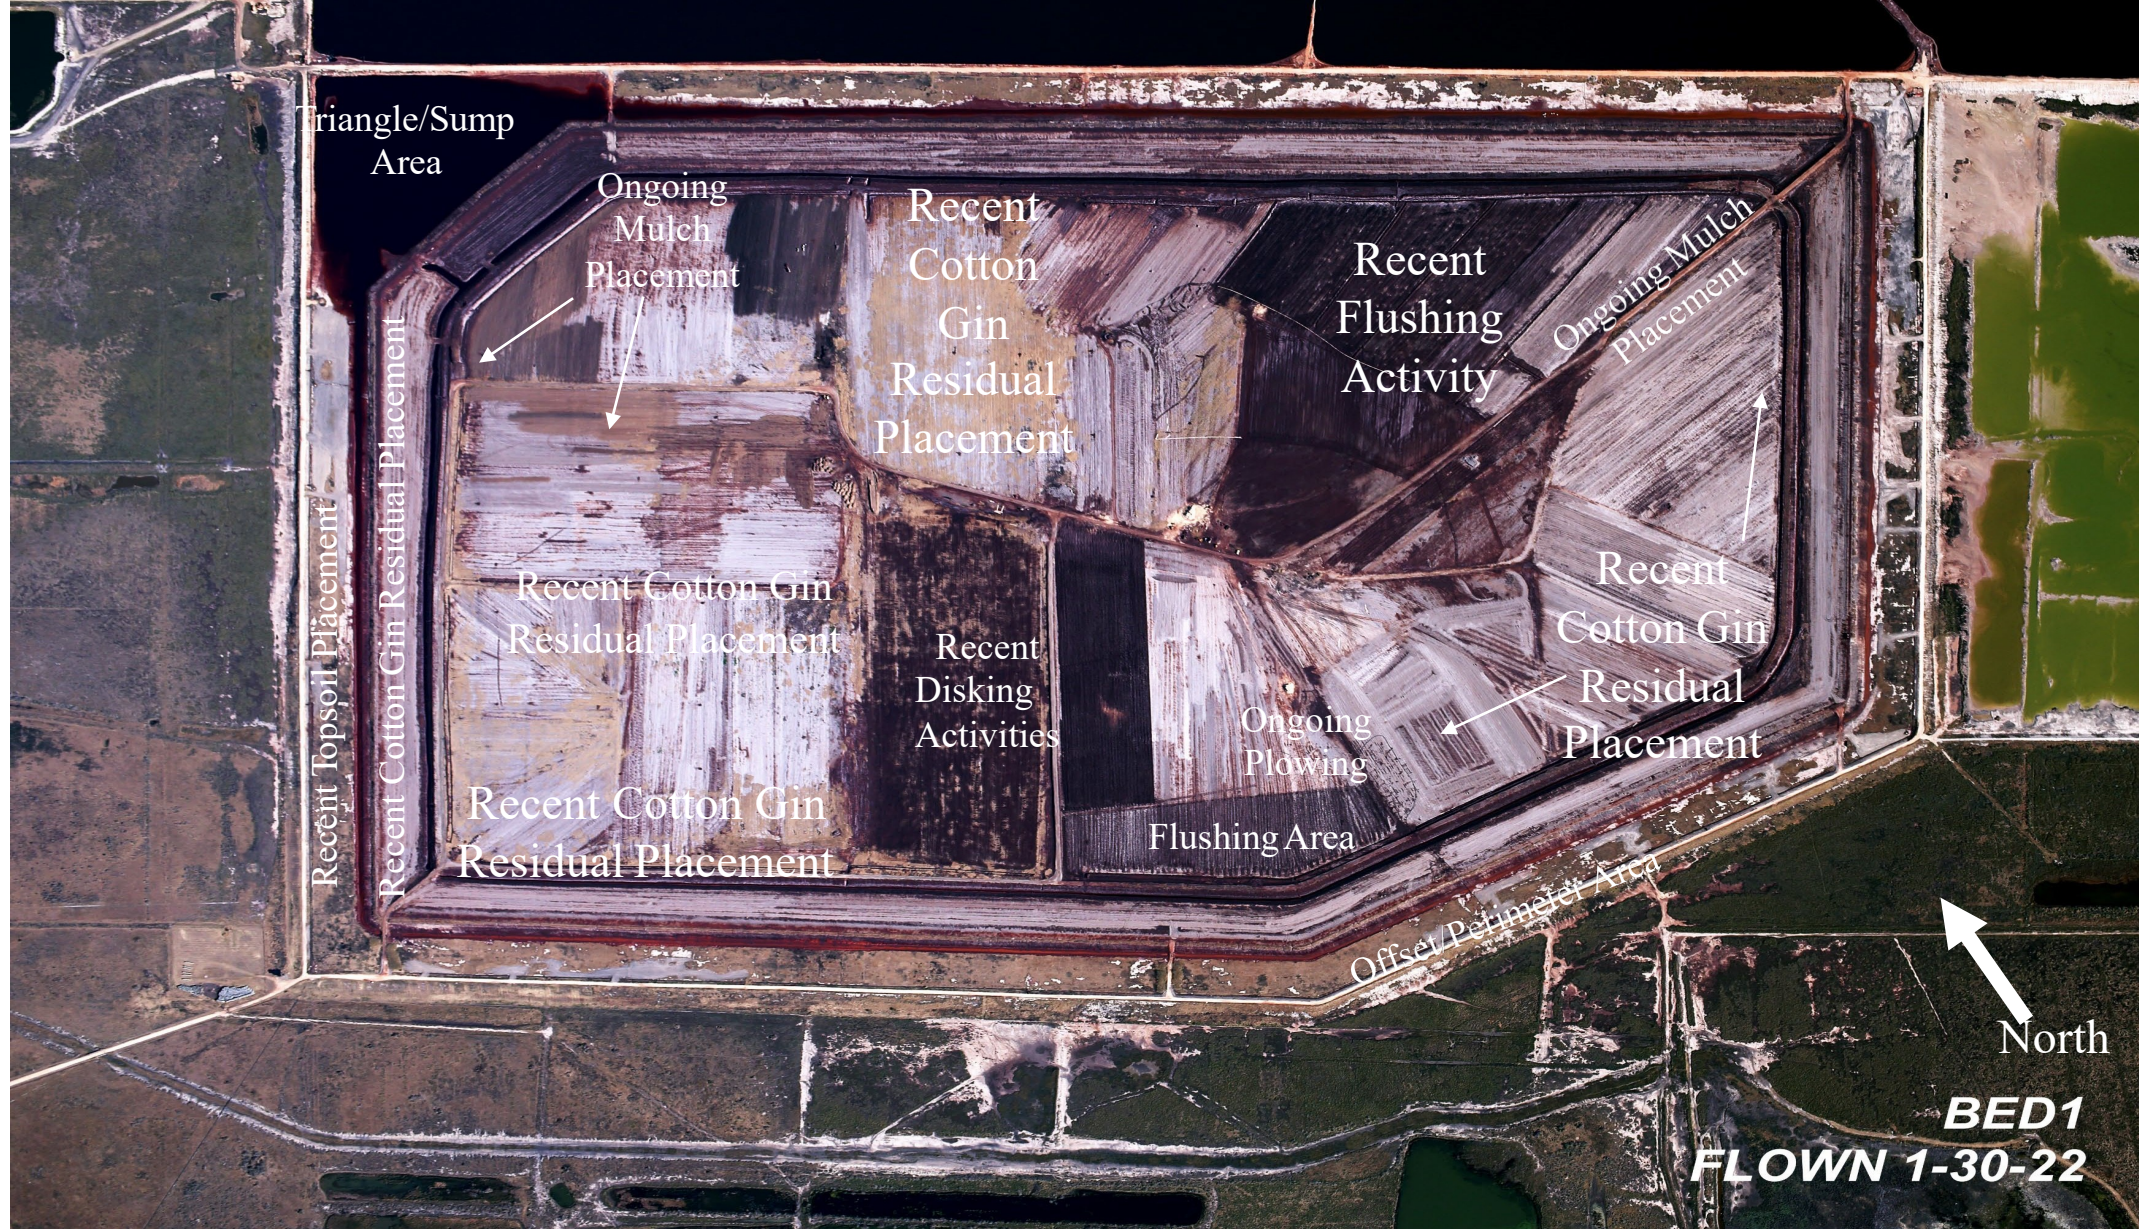
Aerial photograph shows flushing, cotton gin residual, and mulch placement. The vegetated areas have been disked and gypsum applied/flushed in for preparation to fertilize and seed. Repair of the Offset/Perimeter area is ongoing.
